Flood Control Project Maintenance
2018 Structure Summary Report
Overall Unit and Item Ratings

DWR Sutter Maintenance Yard

Butte Slough Drainage Structure

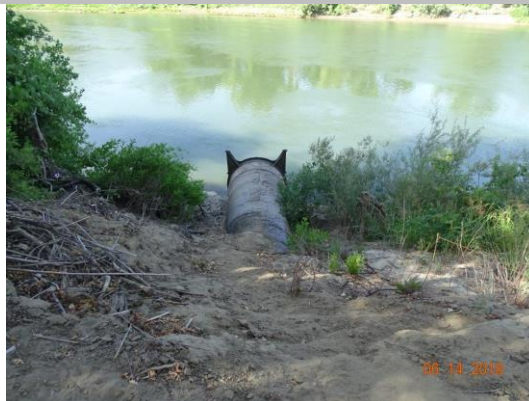
Photo 1 of 8 : ST_2018_NA0060_38_1_20180625_00009.jpg

Butte Slough Drainage Structure on the waterside.

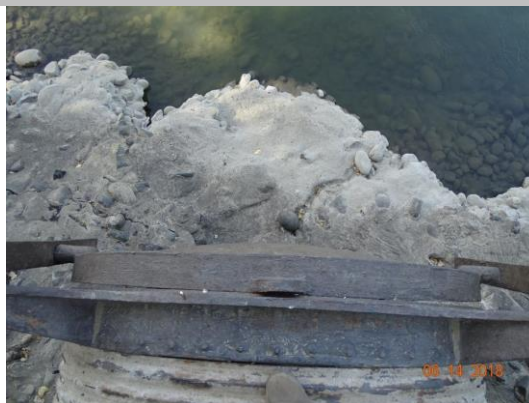
Photo 2 of 8 : ST_2018_NA0060_38_1_20180625_00010.jpg

Top view of the outfall flap gate.

LM Start	0.00	Rating **	M	Issue No.	11
LM End	0.00	Issue Type +	Ma	Location *	
Category	Structures & Concrete Lined Channels	GPS Latitude/Longitude			
		Start		End	
Item	Flap Gates	39.197288 °		39.197288 °	
		-121.943847 °		-121.943847 °	
DWR ID	DWR_NA0060_38_t_2012_11				
Action/Comments					
Inspector Comments: The flap gate appears to be in proper working condition. Minor debris propping the gate open.

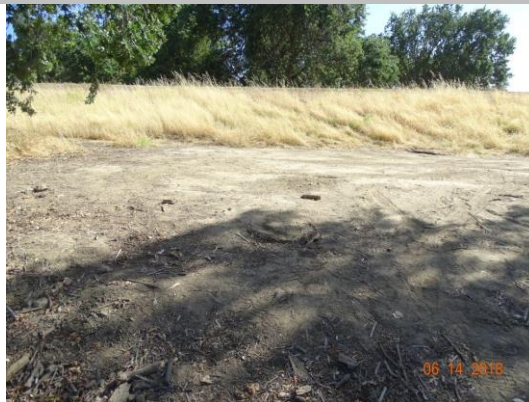
Photo 3 of 8 : ST_2018_NA0060_38_1_20180625_00011.jpg

View of the centerline alignment from the waterside, looking at the levee.

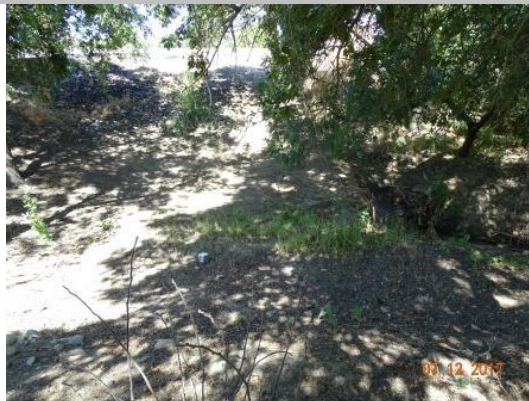
Photo 4 of 8 : ST_2018_NA0060_38_1_20180604_00004.jpg

Butte Slough Drainage Structure on the landside.

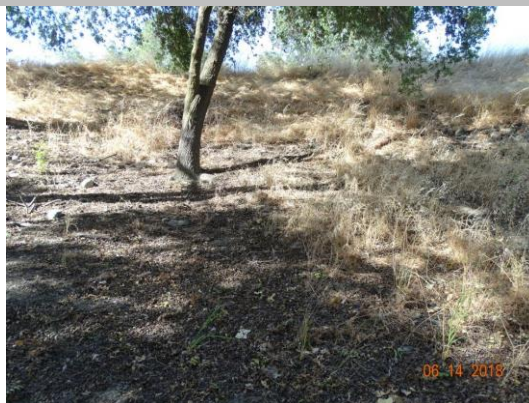
Photo 5 of 8 : ST_2018_NA0060_38_1_20180625_00012.jpg

View of the centerline alignment from the landside, looking at the levee.

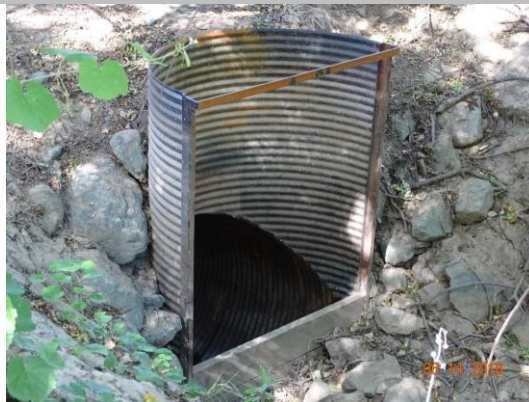
Photo 6 of 8 : ST_2018_NA0060_38_1_20180625_00013.jpg

Butte Slough Drainage Structure on the landside.

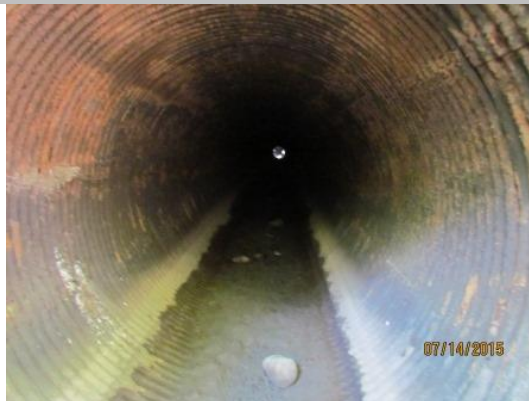
Photo 7 of 8 : ST_2018_NA0060_38_1_20180604_00006.jpg

View of the pipe from the landside.

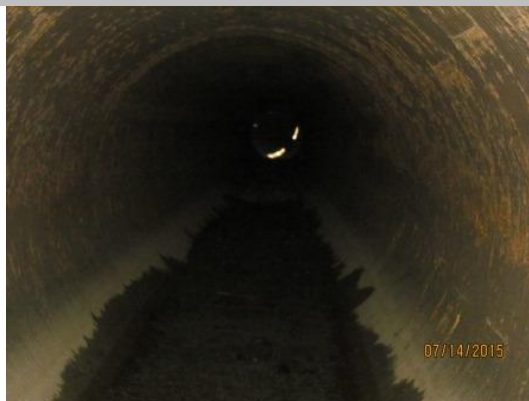
Photo 8 of 8 : ST_2018_NA0060_38_1_20180604_00007.jpg

Zoomed-in view of the pipe from the landside.

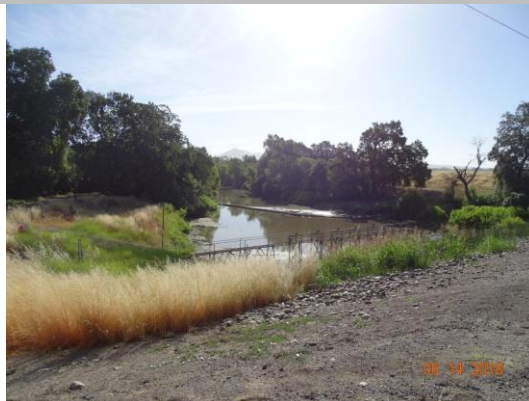
Photo 1 of 8 : ST_2018_NA0060_42_1_20180625_00010.jpg

View of the Butte Slough Outfall Structure from the landside crown.

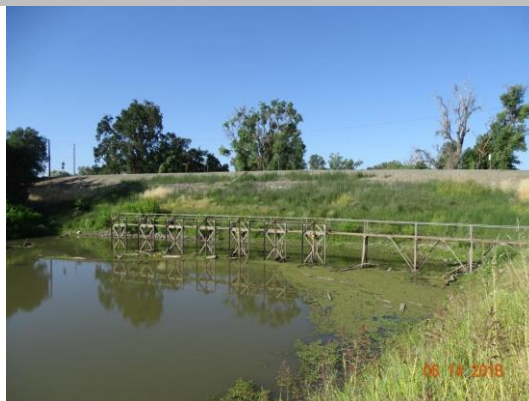
Photo 2 of 8 : ST_2018_NA0060_42_1_20180625_00013.jpg

View of the Butte Slough Outfall Structure on the landside

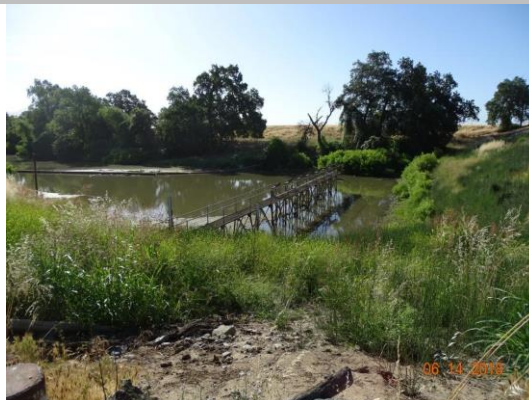
Photo 3 of 8 : ST_2018_NA0060_42_1_20180625_00014.jpg

Another view of the Butte Slough Outfall Structure on the landside.

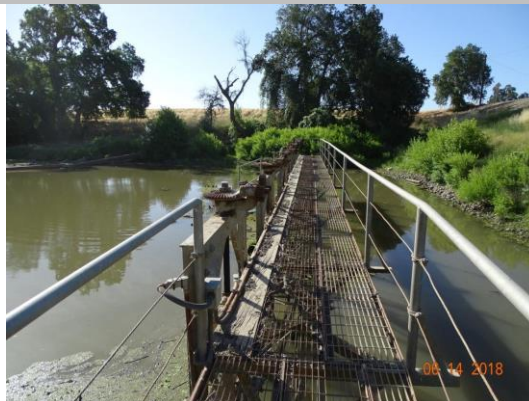
Photo 4 of 8 : ST_2018_NA0060_42_1_20180625_00015.jpg

View of the mechanical gate operation mechanism.

LM Start	0.00	Rating **	A	Issue No.	14
LM End	0.00	Issue Type +	Ma	Location *	
Category	Structures & Concrete Lined Channels			GPS Latitude/Longitude	
				Start	End
Item	Manual Gate Operators			39.194972 °	39.194972 °
				-121.936088 °	-121.936088 °
DWR ID	DWR_NA0060_42_t_2012_14				
Action/Comments					
Inspector Comments: Manual gate operators appear to be in good working condition, however, some lubrication may need to be applied to ensure proper operation of the mechanism.

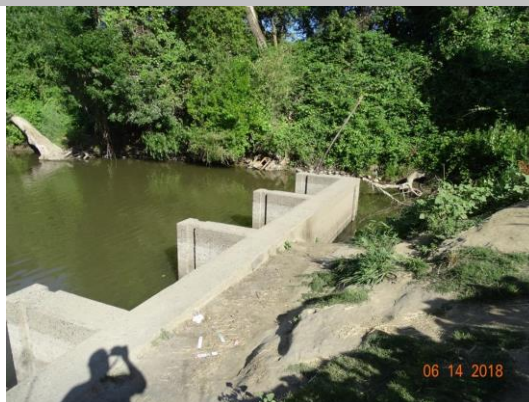
Photo 6 of 8 : ST_2018_NA0060_42_1_20180625_00017.jpg

View of the Butte Slough outfall structure facing Sacramento River.

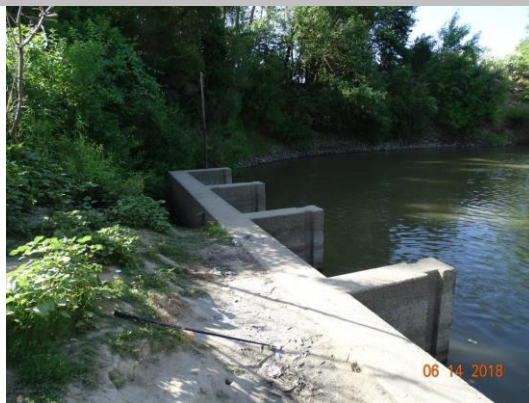
Photo 7 of 8 : ST_2018_NA0060_42_1_20180625_00018.jpg

View of the Butte Slough Outfall Structure on the waterside. Note minor erosion around the headwall.

LM Start	0.00	Rating **	A	Issue No.	4
LM End	0.00	Issue Type +	Ma	Location *	
Category	Structures & Concrete Lined Channels			GPS Latitude/Longitude	
				Start	End
Item	Erosion / Bank Caving			39.194972 °	39.194972 °
				-121.936088 °	-121.936088 °
DWR ID	DWR_NA0060_42_t_2012_4				
Action/Comments					
Inspector Comments: No significant erosion or bank caving was observed on the landside. However, there is minor erosion around the headwall on the waterside which does not appear to undermine the structure at this time.

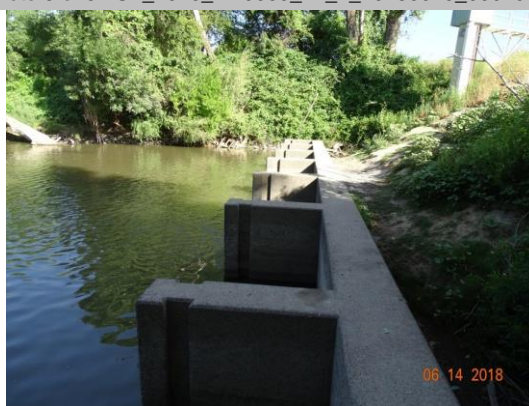
Photo 8 of 8 : ST_2018_NA0060_42_1_20180625_00019.jpg

View of the stop log slots on the waterside. Note minor erosion around the headwall.

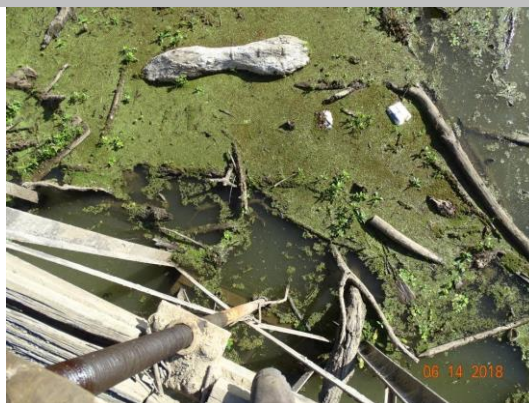
Photo 1 of 1 : ST_2018_NA0060_42_2_20180625_00012.jpg

LM Start	0.00	Rating **	M	Issue No.	2
LM End	0.00	Issue Type +	Ma	Location *	
Category	Structures & Concrete Lined Channels			GPS Latitude/Longitude	
				Start	End
Item	Vegetation & Obstructions			39.194972 °	39.194972 °
				-121.936088 °	-121.936088 °
DWR ID	DWR_NA0060_42_t_2012_2				
Action/Comments					
Inspector Comments: Some logs jammed near the slide gates which may impact proper operation of the structure.

View of the log jammed near the slide gate.

LM Start	0.00	Rating **	A	Issue No.	12
LM End	0.00	Issue Type +	Ma	Location *	
Category	Structures & Concrete Lined Channels	GPS Latitude/Longitude			
		Start		End	
Item	Sluice/Slide Gates	39.194972 °		39.194972 °	
		-121.936088 °		-121.936088 °	
DWR ID	DWR_NA0060_42_t_2012_12				
Action/Comments					
Inspector Comments: Gates appear to be operating normally, however, a few logs were observed near slide gates at the time of inspection.

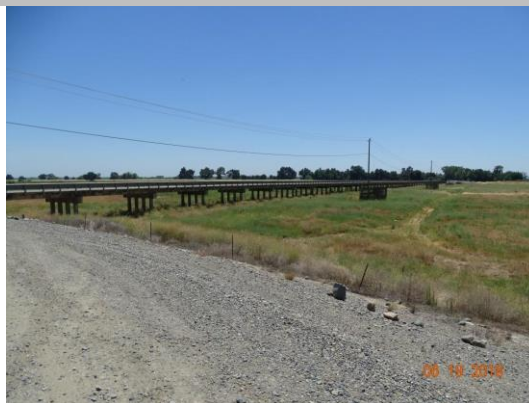
Photo 1 of 7 : ST_2018_NA0060_55_1_20180629_00017.jpg

View of the weir from the left bank looking downstream.

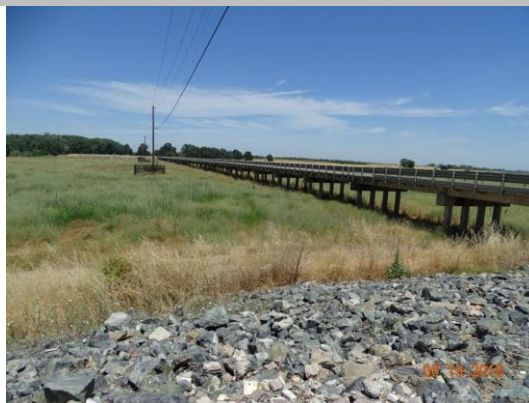
Photo 2 of 7 : ST_2018_NA0060_55_1_20180629_00018.jpg

View of the weir from the right bank looking downstream.

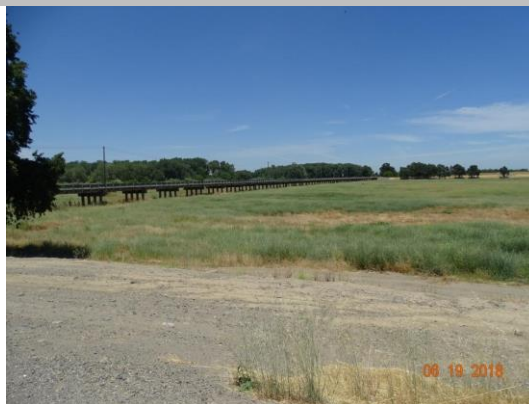
Photo 3 of 7 : ST_2018_NA0060_55_1_20180629_00019.jpg

This is the upstream view of the Colusa Weir structure.

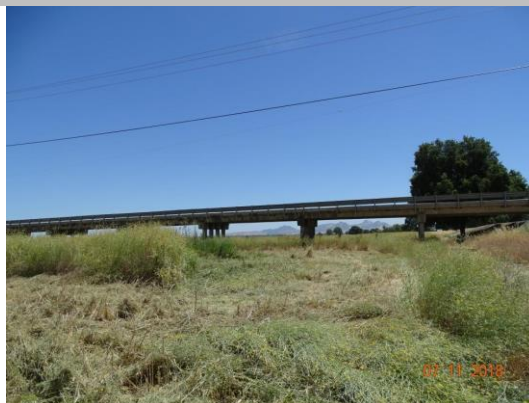
Photo 4 of 7 : ST_2018_NA0060_55_1_20180711_00033.jpg

This is the downstream view of the Colusa Weir structure.

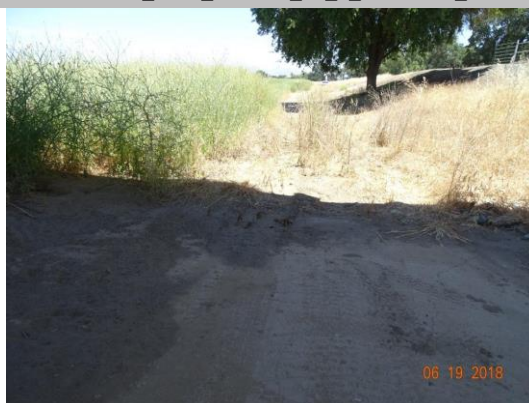
Photo 5 of 7 : ST_2018_NA0060_55_1_20180629_00020.jpg

View of the downstream side of the weir look at the right bank.

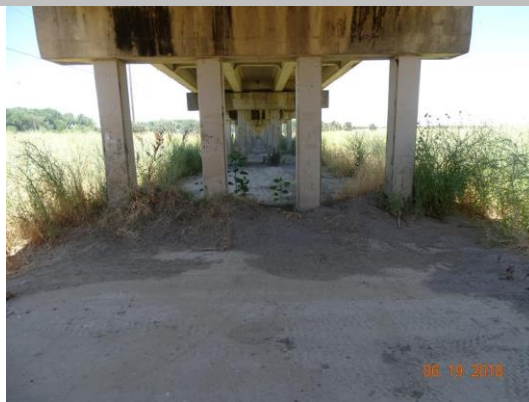
Photo 6 of 7 : ST_2018_NA0060_55_1_20180629_00021.jpg

Typical view of the weir.

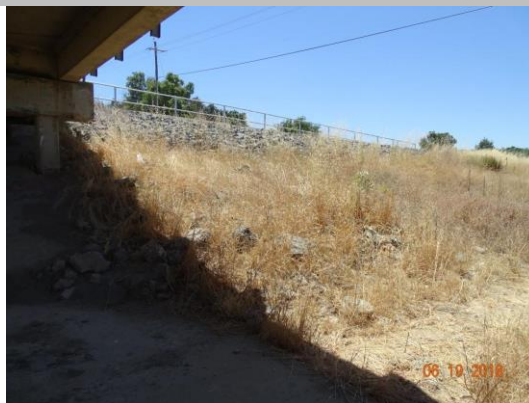
Photo 7 of 7 : ST_2018_NA0060_55_1_20180629_00032.jpg

View of the upstream side of the weir looking at the right bank .

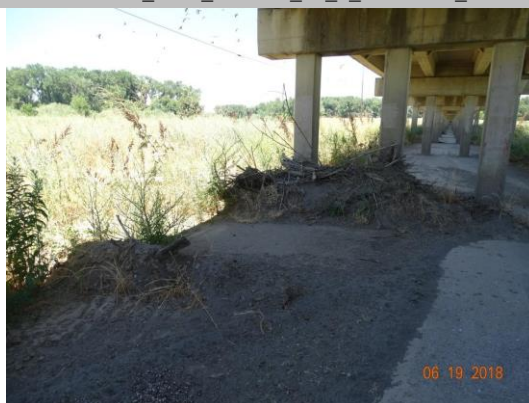
Photo 2 of 2 : ST_2018_NA0060_55_2_20180629_00030.jpg

LM Start	0.00	Rating **	M	Issue No.	2
LM End	0.00	Issue Type +	Ma	Location *	
Category	Structures & Concrete Lined Channels	GPS Latitude/Longitude			
		Start		End	
Item	Vegetation & Obstructions	39.232135 °		39.232135 °	
		-121.996253 °		-121.996253 °	
DWR ID	DWR_NA0060_55_t_2012_2				
Action/Comments					
Inspector Comments: Scattered debris, sediment, and obstructions should be removed. The flow is minimally impeded.

View of the debris that has built up around the piles of the bridge.

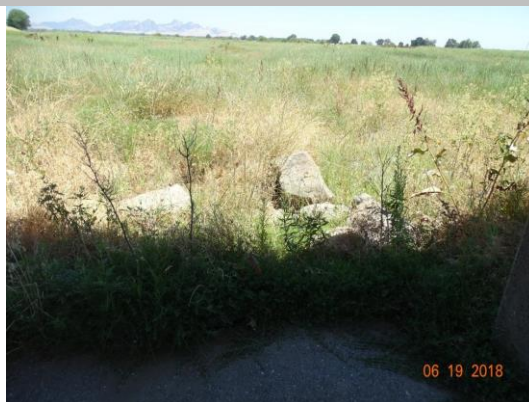
Photo 1 of 1 : ST_2018_NA0060_55_5_20180629_00025.jpg

LM Start	0.00	Rating **	A	Issue No.	5
LM End	0.00	Issue Type +	Ma	Location *	
Category	Structures & Concrete Lined Channels			GPS Latitude/Longitude	
				Start	End
Item	Revetments			39.232135 °	39.232135 °
				-121.996253 °	-121.996253 °
DWR ID	DWR_NA0060_55_t_2012_5				
Action/Comments					
Inspector Comments: Existing riprap protection is properly maintained and is undamaged. Riprap is visible.

View of the riprap on the downstream side of the weir.

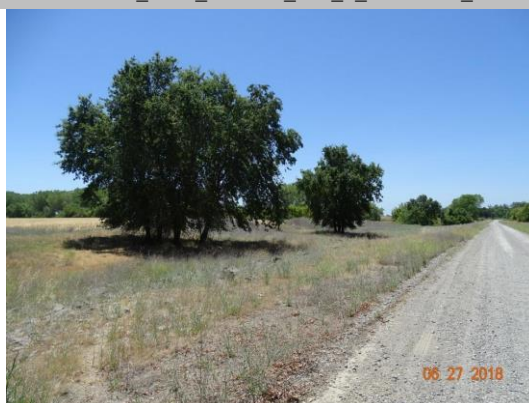
Photo 1 of 2 : ST_2018_NA0060_225_2_20180711_00007.jpg

View of the vegetation on the downstream of the weir.

LM Start	0.00	Rating **	M	Issue No.	2
LM End	0.00	Issue Type +	Ma	Location *	LS
Category	Structures & Concrete Lined Channels			GPS Latitude/Longitude	
				Start	End
Item	Vegetation & Obstructions			39.569247 °	39.569247 °
				-121.982569 °	-121.982569 °
DWR ID	DWR_NA0060_225_t_2013_2				
Action/Comments					
Inspector Comments: Spray the vegetation for approximately 100 feet on both sides of the weir.

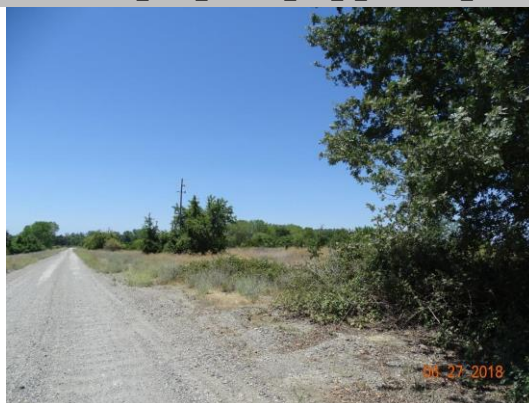
Photo 2 of 2 : ST_2018_NA0060_225_2_20180711_00006.jpg

View of the vegetation on the upstream of the weir.

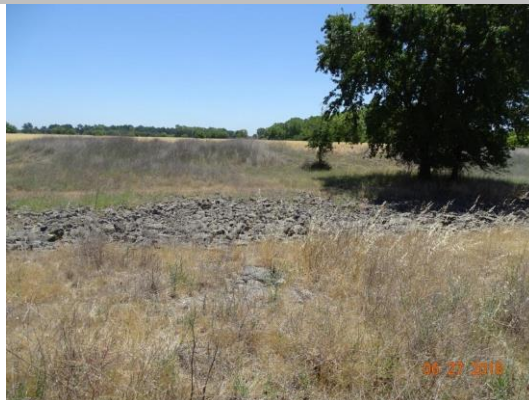
Photo 1 of 1 : ST_2018_NA0060_225_5_20180711_00008.jpg

LM Start	0.00	Rating **	A	Issue No.	5	
LM End	0.00	Issue Type +	Ma	Location *	LS	
Category	Structures & Concrete Lined Channels			GPS Latitude/Longitude		
				Start		End
Item	Revetments			39.569248	°	39.569248
				-121.982569	°	-121.982569
DWR ID	DWR_NA0060_225_t_2013_5					
Action/Comments						
Inspector Comments: Existing riprap protection is properly maintained.

View of the existing revetment on the downstream of the weir.

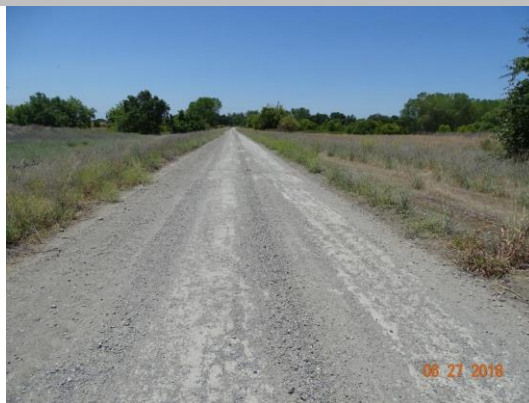
Photo 1 of 1 : ST_2018_NA0060_225_15_20180711_00009.jpg

View of the crown roadway on the top of the weir.

LM Start	0.00	Rating **	A	Issue No.	15
LM End	0.00	Issue Type +	Ma	Location *	LS
Category	Structures & Concrete Lined Channels			GPS Latitude/Longitude	
				Start	End
Item	Concrete Surfaces			39.569248 °	39.569248 °
				-121.982569 °	-121.982569 °
DWR ID	DWR_NA0060_225_t_2013_15				
Action/Comments					
Inspector Comments: Farm equipment needs to stay off of the weir to prevent further damage to the concrete surface.

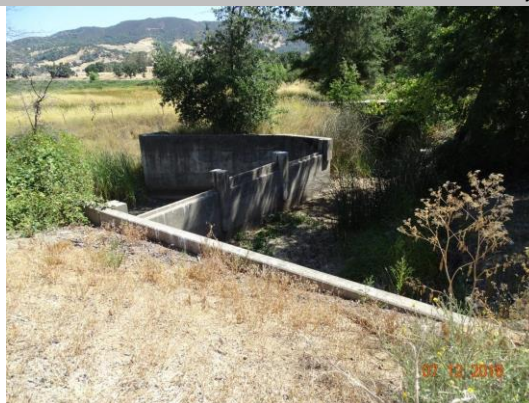
Photo 1 of 1 : ST_2018_NA0060_7_1_20180716_00009.jpg

View of the weir. Summer 2018.

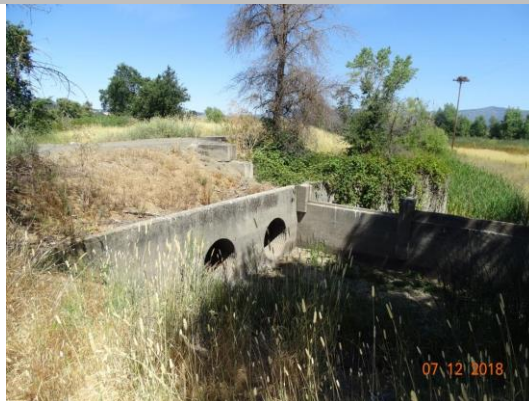
Photo 1 of 2 : ST_2018_NA0060_7_7_20180716_00011.jpg

View of the inlets. Summer 2018.

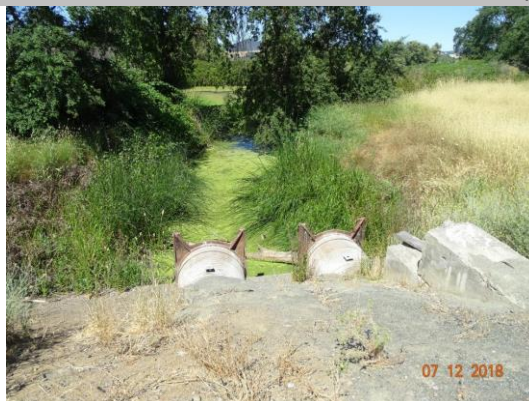
Photo 2 of 2 : ST_2018_NA0060_7_7_20180716_00010.jpg

View of the outlets. Summer 2018.

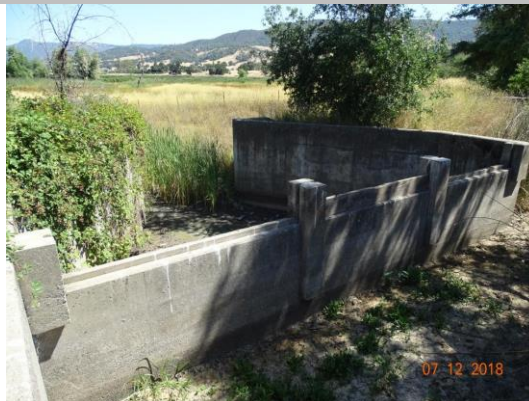
Photo 1 of 3 : ST_2018_NA0060_7_15_20180716_00012.jpg

LM Start	0.00	Rating **	A	Issue No.	15	
LM End	0.00	Issue Type +	Ma	Location *		
Category	Structures & Concrete Lined Channels			GPS Latitude/Longitude		
				Start	End	
Item	Concrete Surfaces			39.126317 °	39.126317 °	
				-122.882733 °	-122.882733 °	
DWR ID	DWR_NA0009_7_t_2012_15					
Action/Comments						
Inspector Comments: There was some minor cracking and scaling on the concrete structure do to its age, but this does not appear to threaten its structural integrity.

View of the concrete structure. Summer 2018.

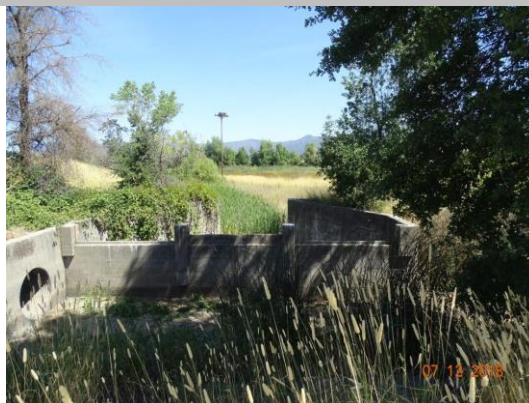
Photo 2 of 3 : ST_2018_NA0060_7_15_20180716_00013.jpg

Additional view of the concrete structure, facing towards the downstream relief channel. Summer 2018.

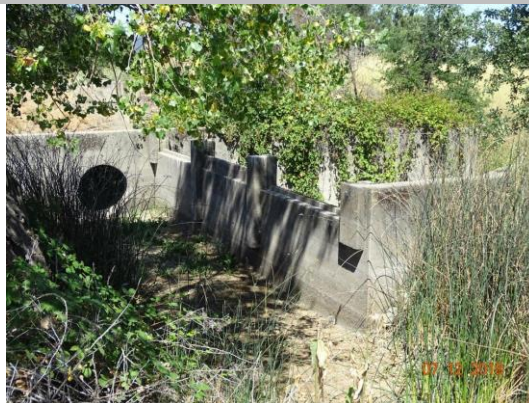
Photo 3 of 3 : ST_2018_NA0060_7_15_20180716_00014.jpg

Additional view of the concrete structure, facing the inlet. Summer 2018.

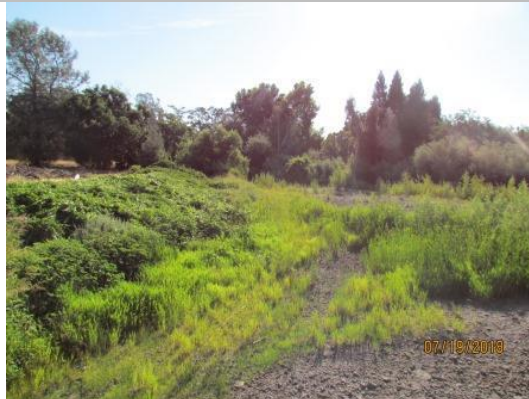
Photo 1 of 4 : ST_2018_NA0060_9_2_20180723_00025.jpg

This is a view looking upstream at the vegetation from the control structure, 2018.

LM Start	0.00	Rating **	A	Issue No.	2
LM End	0.00	Issue Type +	Ma	Location *	
Category	Structures & Concrete Lined Channels			GPS Latitude/Longitude	
				Start	End
Item	Vegetation & Obstructions			39.733555°	39.733555°
				-121.771772°	-121.771772°
DWR ID	DWR_NA0060_9_t_2012_2				
Action/Comments					
Inspector Comments: Vegetation should be removed before winter, 2018.

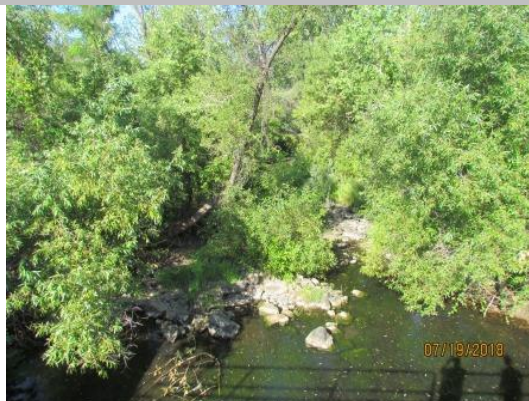
Photo 2 of 4 : ST_2018_NA0060_9_2_20180723_00024.jpg

This is a view looking downstream from the control structure at the vegetation, 2018.

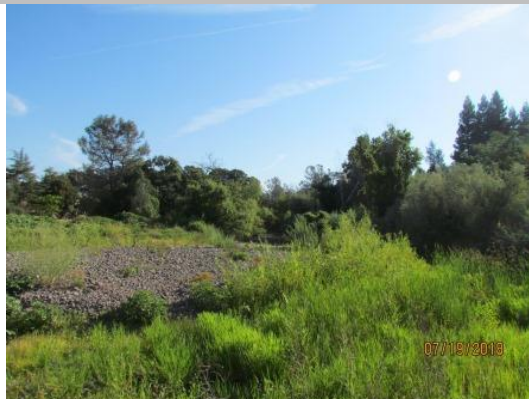
Photo 3 of 4 : ST_2018_NA0060_9_2_20180723_00022.jpg

This is a view looking upstream at the vegetation looking downstream from the weir, 2018.

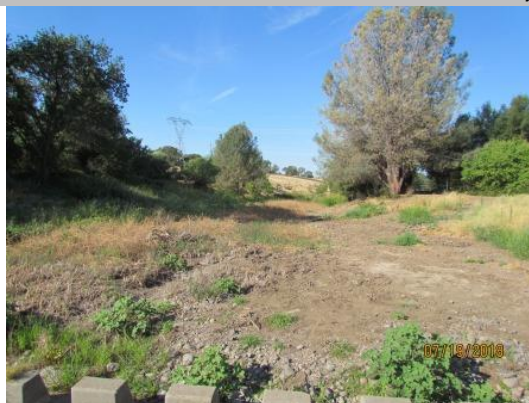
Photo 4 of 4 : ST_2018_NA0060_9_2_20180723_00023.jpg

This is a view looking downstream from the weir at the vegetation, 2018.

LM Start	0.00	Rating **	A	Issue No.	2 (cont)	
LM End	0.00	Issue Type +	Ma	Location *		
Category	Structures & Concrete Lined Channels			GPS Latitude/Longitude		
				Start		End
Item	Vegetation & Obstructions			39.733555 °		39.733555 °
				-121.771772 °		-121.771772 °
DWR ID	DWR_NA0060_9_t_2012_2					
Action/Comments						
Inspector Comments: Vegetation should be removed before winter, 2018.

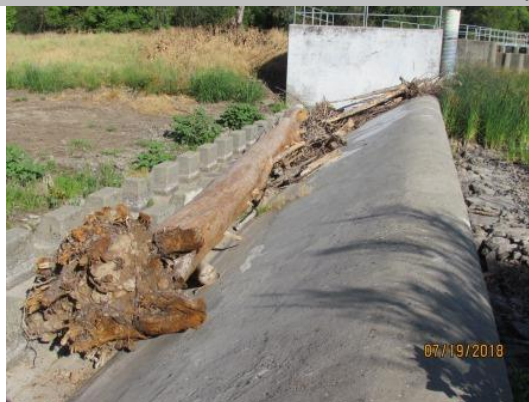
Photo 1 of 2 : ST_2018_NA0060_9_6_20180723_00027.jpg

LM Start	0.00	Rating **	M	Issue No.	6
LM End	0.00	Issue Type +	Ma	Location *	
Category	Structures & Concrete Lined Channels	GPS Latitude/Longitude			
		Start	End		
Item	Encroachments	39.733555 °		39.733555 °	
		-121.771772 °		-121.771772 °	
DWR ID	DWR_NA0060_9_t_2012_6				
Action/Comments					
Inspector Comments: Wood debris encroachment in the weir may inhibit flows and should be removed, 2018.

View of a few logs trapped in the weir, flows may be effected by them, 2018.

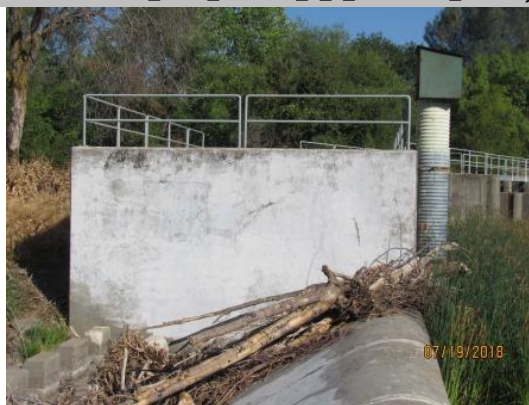
Photo 2 of 2 : ST_2018_NA0060_9_6_20180723_00026.jpg

View of a few logs trapped in the weir, flows may be effected by them, 2018.

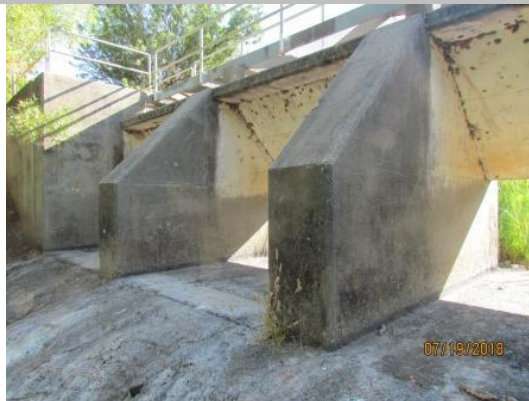
Photo 1 of 2 : ST_2018_NA0060_9_7_20180723_00028.jpg

LM Start	0.00	Rating **	N	Issue No.	7
LM End	0.00	Issue Type +	Ma	Location *	
Category	Structures & Concrete Lined Channels			GPS Latitude/Longitude	
				Start	End
Item	Culverts: Inlets / Outlets			39.733555 °	39.733555 °
				-121.771772 °	-121.771772 °
DWR ID	DWR_NA0060_9_t_2012_7				
Action/Comments					
Inspector Comments: Inlets and outlets are clear of obstructions, 2018.

View of outlets clear of obstructions, 2018.

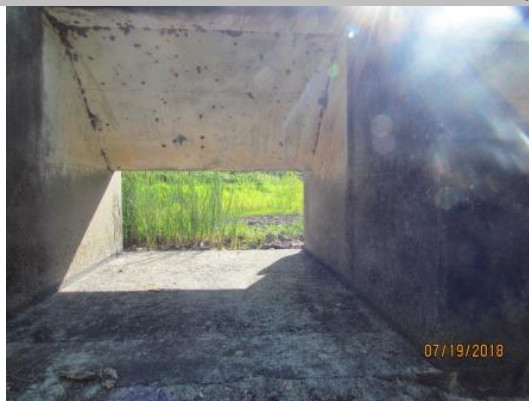
Photo 2 of 2 : ST_2018_NA0060_9_7_20180723_00029.jpg

Closer view of outlets clear of obstructions, 2018.

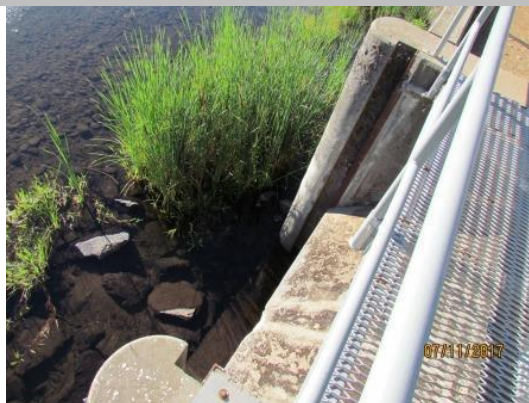
Photo 1 of 2 : ST_2018_NA0060_9_12_20180716_00012.jpg

LM Start	0.00	Rating **	A	Issue No.	12
LM End	0.00	Issue Type +	Ma	Location *	
Category	Structures & Concrete Lined Channels			GPS Latitude/Longitude	
				Start	End
Item	Sluice/Slide Gates			39.733555 °	39.733555 °
				-121.771772 °	-121.771772 °
DWR ID	DWR_NA0060_9_t_2012_12				
Action/Comments					
Inspector Comments: The two sluice gates on either end of the control structure are in good condition, 2018.

View of the two sluice gates on either end of the control structure, 2017.

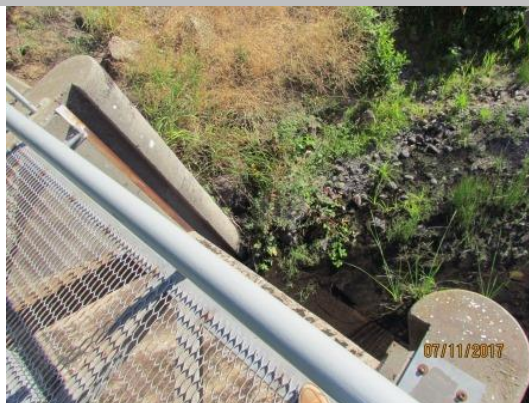
Photo 2 of 2 : ST_2018_NA0060_9_12_20180716_00013.jpg

View of the two sluice gates on either end of the control structure, 2017.

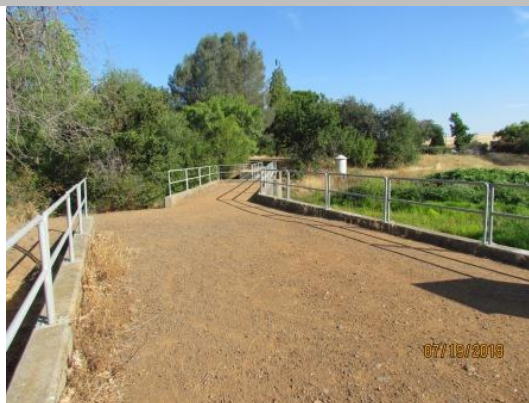
Photo 1 of 2 : ST_2018_NA0060_9_23_20180723_00031.jpg

Hand rails are installed and are in good condition, 2018.

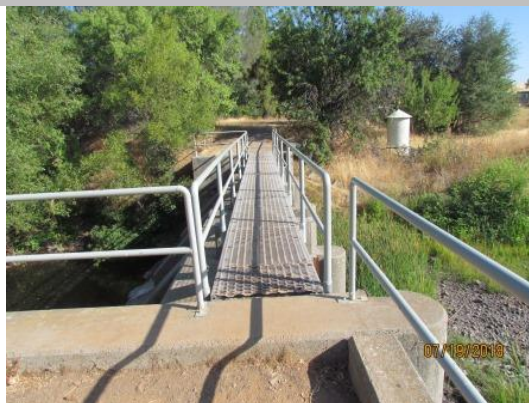
Photo 2 of 2 : ST_2018_NA0060_9_23_20180723_00032.jpg

Hand rails are installed and are in good condition, 2018.

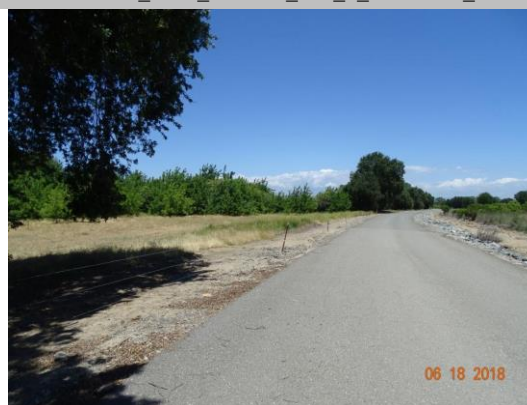
Photo 1 of 1 : ST_2018_NA0060_228_2_20180626_00007.jpg

View of the vegetation on the upstream side of the weir.

LM Start	0.00	Rating **	M	Issue No.	2
LM End	0.00	Issue Type +	Ma	Location *	WS
Category	Structures & Concrete Lined Channels			GPS Latitude/Longitude	
				Start	End
Item	Vegetation & Obstructions			39.674690 °	39.674690 °
				-121.947013 °	-121.947013 °
DWR ID	DWR_NA0014_228_t_2013_2				
Action/Comments					
Inspector Comments: The vegetation should be sprayed back approximately 20 feet from both sides of the weir.

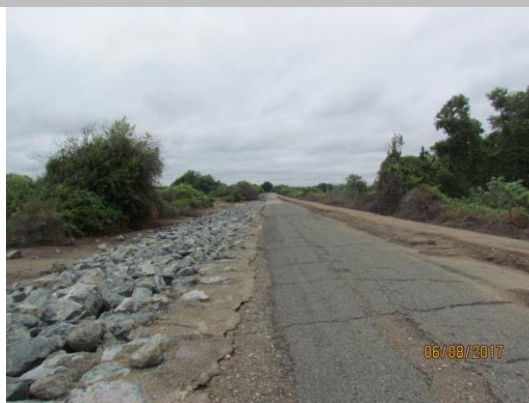
Photo 2 of 2 : ST_2018_NA0060_228_4_20180604_00003.jpg

LM Start	0.00	Rating **	M	Issue No.	4
LM End	0.00	Issue Type +	Ma	Location *	WS
Category	Structures & Concrete Lined Channels			GPS Latitude/Longitude	
				Start	End
Item	Erosion / Bank Caving			39.668789 °	39.668789 °
				-121.957170 °	-121.957170 °
DWR ID	DWR_NA0014_228_t_2013_4				
Action/Comments					
Inspector Comments: The soil erosion on the upstream side of the weir needs repair.

View of the erosion on the upstream side of the weir during 2017 high water.

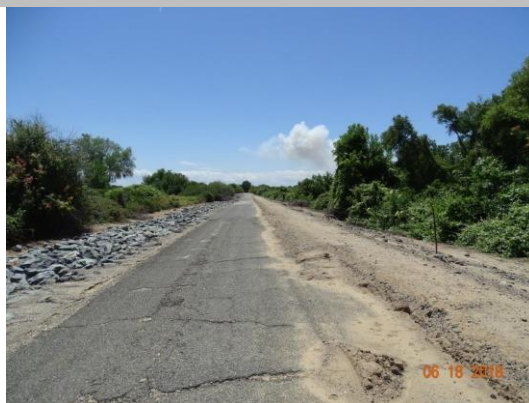
Photo 1 of 1 : ST_2018_NA0060_228_5_20180626_00009.jpg

LM Start	0.00	Rating **	A	Issue No.	5
LM End	0.00	Issue Type +	Ma	Location *	WS
Category	Structures & Concrete Lined Channels			GPS Latitude/Longitude	
				Start	End
Item	Revetments			39.674690 °	39.674690 °
				-121.947010 °	-121.947010 °
DWR ID	DWR_NA0014_228_t_2013_5				
Action/Comments					
Inspector Comments: The riprap is properly maintained.

View of the revetment on the downstream side of the weir.

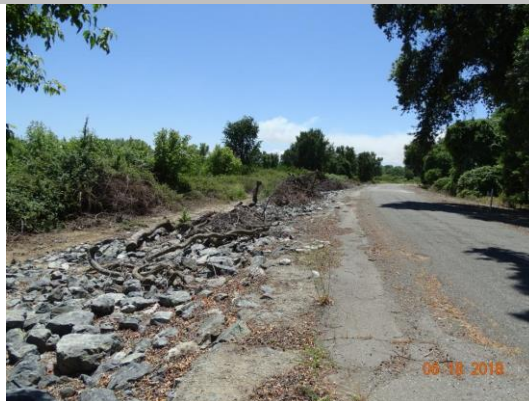
Photo 1 of 1 : ST_2018_NA0060_228_6_20180626_00010.jpg

View of the debris on the revetment.

LM Start	0.00	Rating **	M	Issue No.	6
LM End	0.00	Issue Type +	Ma	Location *	WS
Category	Structures & Concrete Lined Channels			GPS Latitude/Longitude	
				Start	End
Item	Encroachments			39.674690 °	39.674690 °
				-121.947010 °	-121.947010 °
DWR ID	DWR_NA0014_228_t_2013_6				
Action/Comments					
Inspector Comments: Remove the debris on the revetment.

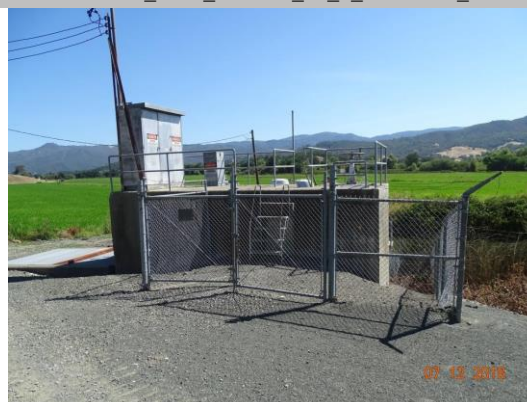
Photo 1 of 3 : ST_2018_NA0060_17_3_20180716_00019.jpg

LM Start	0.00	Rating **	M	Issue No.	3
LM End	0.00	Issue Type +	Ma	Location *	
Category	Pump Stations			GPS Latitude/Longitude	
				Start	End
Item	Plant Building			39.142300 °	39.142300 °
				-122.902350 °	-122.902350 °
DWR ID	DWR_NA0060_17_t_2012_3				
Action/Comments					
Inspector Comments: The plant building was in good structural condition with no major cracks that could threaten the integrity of the building. However, the adjacent structure had some differential settlement.

View of the pumping plant. Summer 2018.

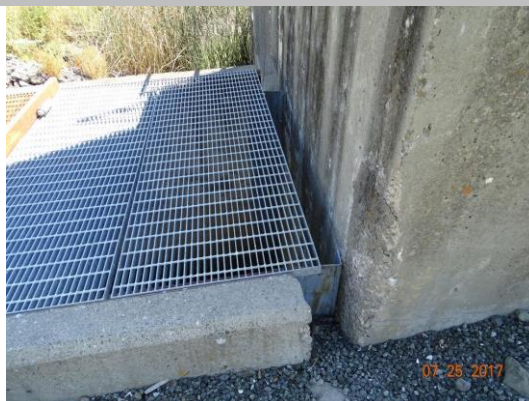
Photo 3 of 3 : ST_2018_NA0060_17_3_20180612_00005.jpg

View of the settlement next to the pumping plant. Summer 2017.

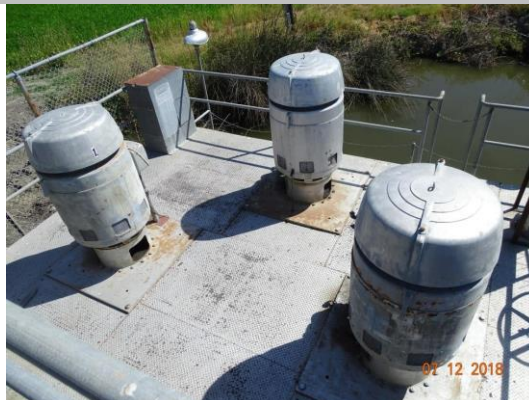
Photo 1 of 1 : ST_2018_NA0060_17_7_20180716_00022.jpg

LM Start	0.00	Rating **	A	Issue No.	7
LM End	0.00	Issue Type +	Ma	Location *	
Category	Pump Stations			GPS Latitude/Longitude	
				Start	End
Item	Pumps			39.142300 °	39.142300 °
				-122.902350 °	-122.902350 °
DWR ID	DWR_NA0060_17_t_2012_7				
Action/Comments					
Inspector Comments: The pumps appeared to be in good working condition and properly maintained including proper lubrication level.

View of the three pumps. Summer 2018.

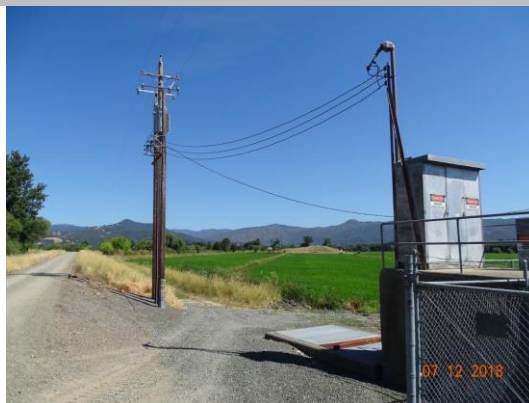
Photo 1 of 1 : ST_2018_NA0060_17_8_20180716_00023.jpg

LM Start	0.00	Rating **	A	Issue No.	8
LM End	0.00	Issue Type +	Ma	Location *	
Category	Pump Stations			GPS Latitude/Longitude	
				Start	End
Item	Power			39.142300 °	39.142300 °
				-122.902350 °	-122.902350 °
DWR ID	DWR_NA0060_17_t_2012_8				
Action/Comments					
Inspector Comments: The power source appears to be reliable and safe.

View of the powerlines that power the plant. Summer 2018.

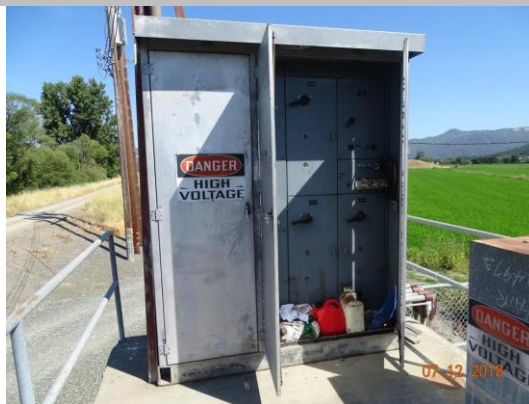
Photo 1 of 1 : ST_2018_NA0060_17_11_20180716_00024.jpg

LM Start	0.00	Rating **	A	Issue No.	11
LM End	0.00	Issue Type +	Ma	Location *	
Category	Pump Stations			GPS Latitude/Longitude	
				Start	End
Item	Pump Control Systems			39.142300 °	39.142300 °
				-122.902350 °	-122.902350 °
DWR ID	DWR_NA0060_17_t_2012_11				
Action/Comments					
Inspector Comments: The pump control systems appeared to be operational and free of damage.

View of the pump controls. Summer 2018.

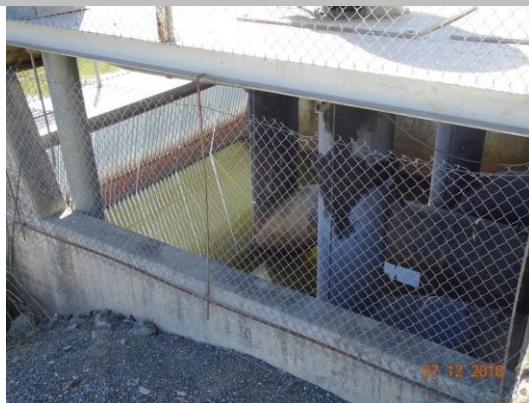
Photo 1 of 1 : ST_2018_NA0060_17_12_20180716_00032.jpg

LM Start	0.00	Rating **	A	Issue No.	12	
LM End	0.00	Issue Type +	Ma	Location *		
Category	Pump Stations			GPS Latitude/Longitude		
				Start		End
Item	Sumps/Wet Well			39.142300 °		39.142300 °
				-122.902350 °		-122.902350 °
DWR ID	DWR_NA0060_17_t_2013_12					
Action/Comments						
Inspector Comments: Wet wells were clear of debris.

View of the wet well. Summer 2018.

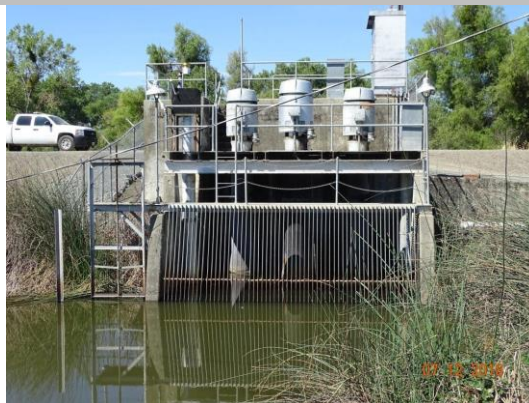
Photo 1 of 1 : ST_2018_NA0060_17_13_20180716_00026.jpg

LM Start	0.00	Rating **	A	Issue No.	13
LM End	0.00	Issue Type +	Ma	Location *	
Category	Pump Stations			GPS Latitude/Longitude	
				Start	End
Item	Trash Racks			39.142300 °	39.142300 °
				-122.902350 °	-122.902350 °
DWR ID	DWR_NA0060_17_t_2012_13				
Action/Comments					
Inspector Comments: Trash racks appeared to be in good condition and free of debris.

View of the trash racks. Summer 2018.

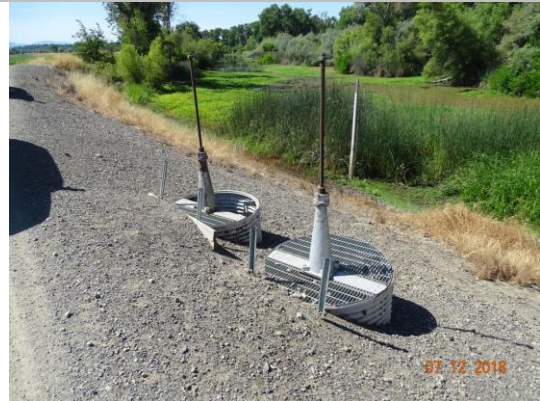
Photo 1 of 1 : ST_2018_NA0060_17_15_20180716_00027.jpg

LM Start	0.00	Rating **	A	Issue No.	15
LM End	0.00	Issue Type +	Ma	Location *	
Category	Pump Stations			GPS Latitude/Longitude	
				Start	End
Item	Sluice / Slide Gates			39.142300 °	39.142300 °
				-122.902350 °	-122.902350 °
DWR ID	DWR_NA0060_17_t_2013_15				
Action/Comments					
Inspector Comments: The slide gates appeared to be in a good working condition.

View of the slide gates. Summer 2018.

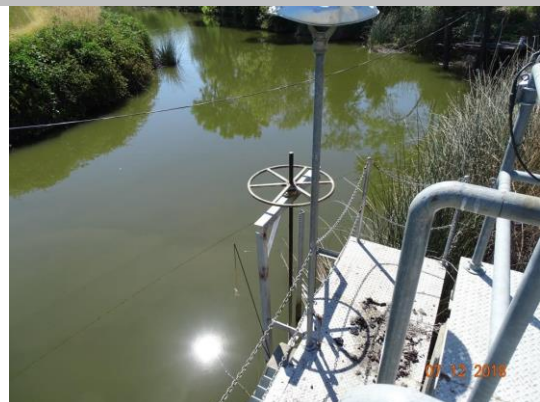
Photo 1 of 2 : ST_2018_NA0060_17_17_20180716_00029.jpg

LM Start	0.00	Rating **	A	Issue No.	17
LM End	0.00	Issue Type +	Ma	Location *	
Category	Pump Stations			GPS Latitude/Longitude	
				Start	End
Item	Manual Gate Operators			39.142300 °	39.142300 °
				-122.902350 °	-122.902350 °
DWR ID	DWR_NA0060_17_t_2012_17				
Action/Comments					
Inspector Comments: The manual gate operators appeared to be in good working condition.

View of a manual operator at the plant. Summer 2018.

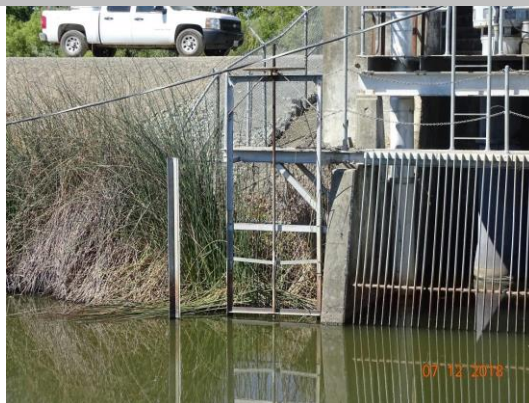
Photo 2 of 2 : ST_2018_NA0060_17_17_20180716_00030.jpg

LM Start	0.00	Rating **	A	Issue No.	17 (cont)	
LM End	0.00	Issue Type +	Ma	Location *		
Category	Pump Stations			GPS Latitude/Longitude		
				Start	End	
Item	Manual Gate Operators			39.142300 °	39.142300 °	
				-122.902350 °	-122.902350 °	
DWR ID	DWR_NA0060_17_t_2012_17					
Action/Comments						
Inspector Comments: The manual gate operators appeared to be in good working condition.

Another view of the manual operator. Summer 2018.

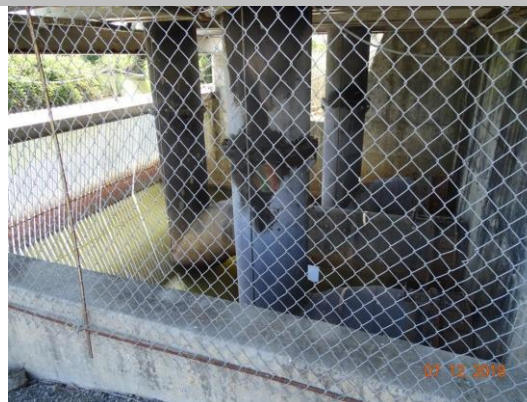
Photo 1 of 1 : ST_2018_NA0060_17_22_20180716_00031.jpg

LM Start	0.00	Rating **	A	Issue No.	22
LM End	0.00	Issue Type +	Ma	Location *	
Category	Pump Stations			GPS Latitude/Longitude	
				Start	End
Item	Intake and Discharge Pipes			39.142300 °	39.142300 °
				-122.902350 °	-122.902350 °
DWR ID	DWR_NA0060_17_t_2012_22				
Action/Comments					
Inspector Comments: The pipes appeared to be in good working condition.

View of the intake pipes. Summer 2018.

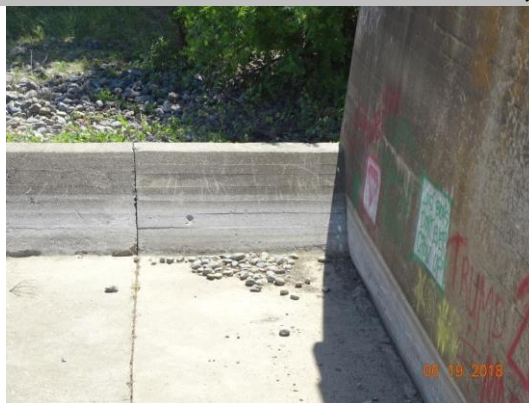
Photo 1 of 1 : ST_2018_NA0060_4_2_20180629_00029.jpg

LM Start	0.00	Rating **	A	Issue No.	2
LM End	0.00	Issue Type +	Ma	Location *	
Category	Structures & Concrete Lined Channels			GPS Latitude/Longitude	
				Start	End
Item	Vegetation & Obstructions			39.338242 °	39.338242 °
				-122.022073 °	-122.022073 °
DWR ID	DWR_NA0060_4_t_2012_2				
Action/Comments					
Inspector Comments: Minimal, scattered obstructions or vegetation. The flow is not impeded.

View of the very small amount of soil and rock in the weir near the right abutment.

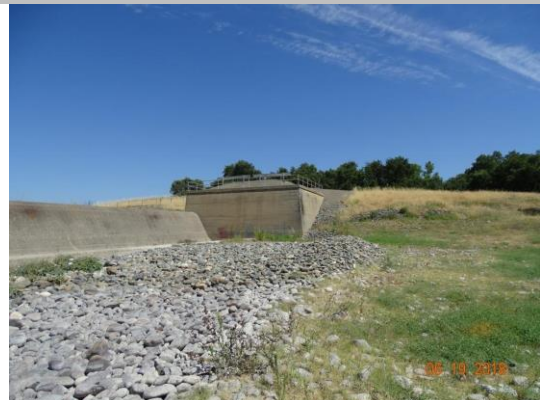
Photo 1 of 2 : ST_2018_NA0060_4_5_20180629_00030.jpg

LM Start	0.00	Rating **	A	Issue No.	5
LM End	0.00	Issue Type +	Ma	Location *	
Category	Structures & Concrete Lined Channels			GPS Latitude/Longitude	
				Start	End
Item	Revetments			39.338242 °	39.338242 °
				-122.022073 °	-122.022073 °
DWR ID	DWR_NA0060_4_t_2012_5				
Action/Comments					
Inspector Comments: Existing riprap protection is properly maintained and is undamaged. Riprap clearly visible.

View of revetment at outfall of weir looking towards the left bank.

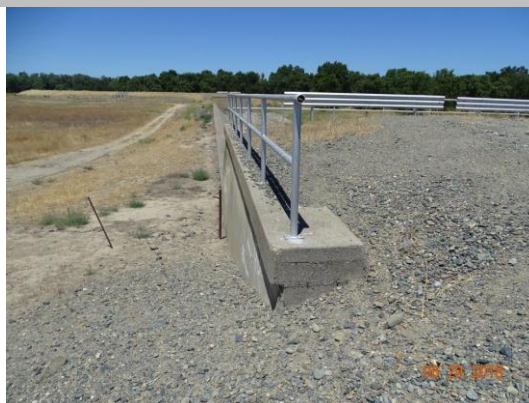
Photo 1 of 2 : ST_2018_NA0060_4_23_20180711_00037.jpg

LM Start	0.00	Rating **	A	Issue No.	23
LM End	0.00	Issue Type +	Ma	Location *	
Category	Structures & Concrete Lined Channels	GPS Latitude/Longitude			
		Start		End	
Item	Safety	39.338242 °		39.338242 °	
		-122.022073 °		-122.022073 °	
DWR ID	DWR_NA0060_4_t_2012_23				
Action/Comments					
Inspector Comments: Safety hardware installed. Adequate protection for fall hazards exist. No hazardous conditions that might affect the operation of the structure exist.

View of the safety railing installed with added guard rail around the right bank weir abutment.

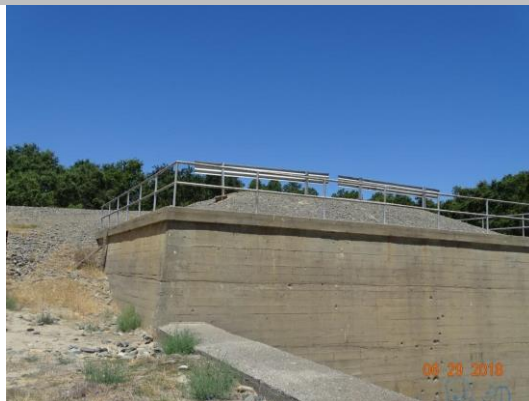
Photo 2 of 2 : ST_2018_NA0060_4_23_20180711_00038.jpg

View of the safety railing installed with added guard rail around the left bank weir abutment.

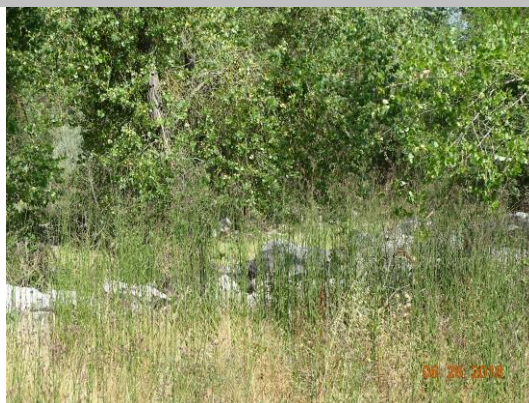
Photo 1 of 2 : ST_2018_NA0060_54_2_20180626_00010.jpg

LM Start	0.00	Rating **	M	Issue No.	2	
LM End	0.00	Issue Type +	Ma	Location *		
Category	Structures & Concrete Lined Channels			GPS Latitude/Longitude		
				Start	End	
Item	Vegetation & Obstructions			38.895500 °	38.887450 °	
				-121.616950 °	-121.615330 °	
DWR ID	DWR_NA0060_54_t_2012_2					
Action/Comments						
Inspector Comments: Minimal, scattered obstructions or vegetation. The vegetation should be cleared and trees trimmed up. May impede flow in a high water event.

View of the vegetation around the weir looking downstream, 2018

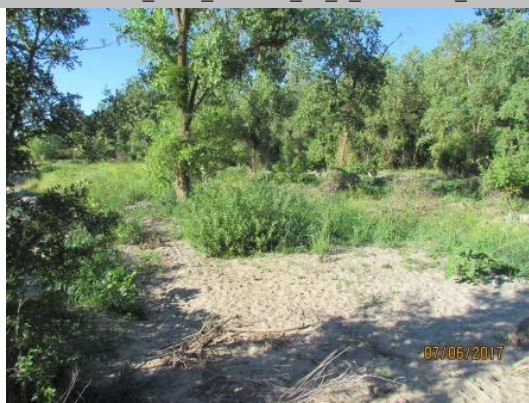
Photo 2 of 2 : ST_2018_NA0060_54_2_20180530_00007.jpg

View of the vegetation that is overgrowing the weir looking south, 2017.

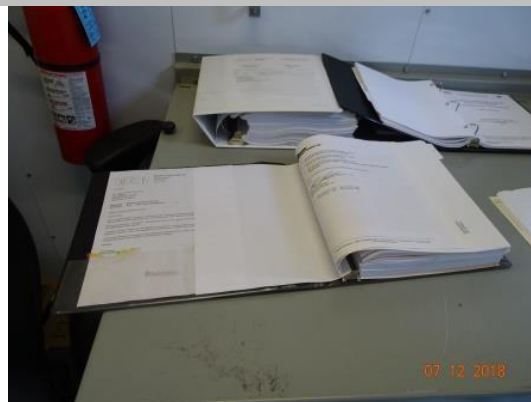
Photo 1 of 1 : ST_2018_NA0060_21_2_20180713_00025.jpg

LM Start	0.00	Rating **	A	Issue No.	2	
LM End	0.00	Issue Type +	Ma	Location *		
Category	Pump Stations			GPS Latitude/Longitude		
				Start	End	
Item	Operation & Maintenance Manual			38.931815 °	38.931815 °	
				-121.634331 °	-121.634331 °	
DWR ID	DWR_NA0060_21_t_2012_2					
Action/Comments						
Inspector Comments: The O&M manual is available at the site. Sutter Maintenance Yard will provide documentation of future maintenance.

View of the O&M manual. Photo taken July, 2018.

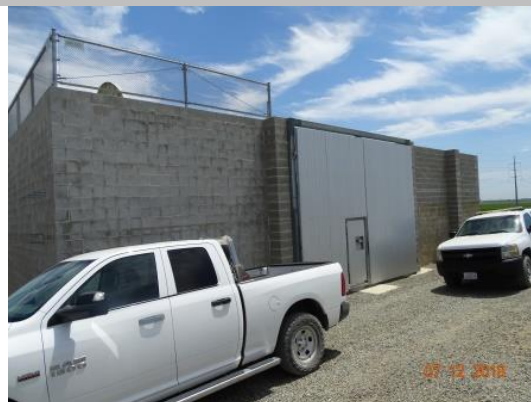
Photo 1 of 1 : ST_2018_NA0060_21_3_20180713_00044.jpg

LM Start	0.00	Rating **	A	Issue No.	3
LM End	0.00	Issue Type +	Ma	Location *	
Category	Pump Stations			GPS Latitude/Longitude	
				Start	End
Item	Plant Building			38.931815 °	38.931815 °
				-121.634331 °	-121.634331 °
DWR ID	DWR_NA0060_21_t_2012_3				
Action/Comments					
Inspector Comments: Plant building appears to be in good working order.

View of the outside of the facility. Photo taken July, 2018.

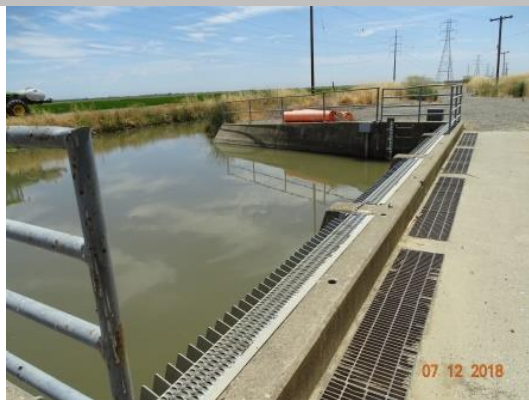
Photo 1 of 6 : ST_2018_NA0060_21_5_20180713_00031.jpg

LM Start	0.00	Rating **	M	Issue No.	5
LM End	0.00	Issue Type +	Ma	Location *	
Category	Pump Stations			GPS Latitude/Longitude	
				Start	End
Item	Safety			38.931815 °	38.931815 °
				-121.634331 °	-121.634331 °
DWR ID	DWR_NA0060_21_t_2012_5				
Action/Comments					
Inspector Comments: Missing fall protection railing at the pump inlet.

View of missing fall protection railing at the pump inlet. Photo taken July, 2018.

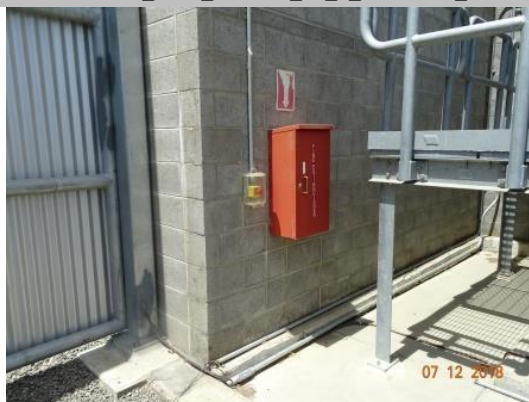
Photo 2 of 6 : ST_2018_NA0060_21_5_20180713_00027.jpg

View of fire extinguisher next to the entrance gate. Photo taken July, 2018.

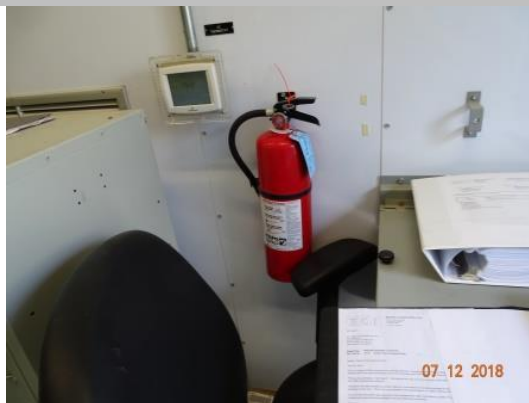
Photo 3 of 6 : ST_2018_NA0060_21_5_20180713_00028.jpg

Fire extinguisher in the pump control building. Photo taken July, 2018.

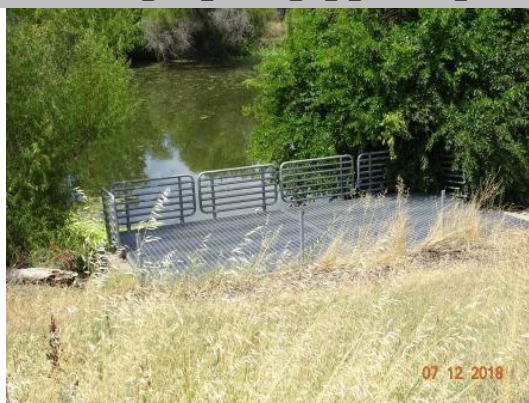
Photo 4 of 6 : ST_2018_NA0060_21_5_20180713_00029.jpg

View of fall protection railing and grate over the pump outlet. Photo taken July, 2018.

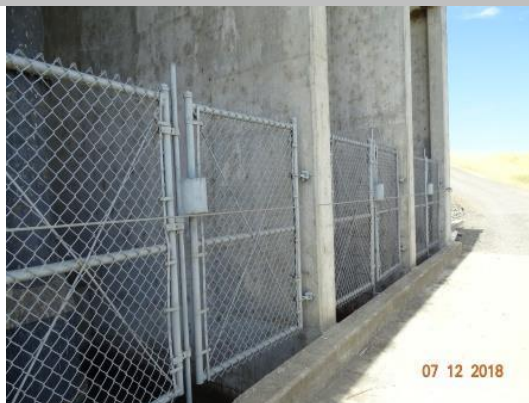
Photo 5 of 6 : ST_2018_NA0060_21_5_20180713_00030.jpg

LM Start	0.00	Rating **	M	Issue No.	5 (cont)	
LM End	0.00	Issue Type +	Ma	Location *		
Category	Pump Stations			GPS Latitude/Longitude		
				Start		End
Item	Safety			38.931815 °		38.931815 °
				-121.634331 °		-121.634331 °
DWR ID	DWR_NA0060_21_t_2012_5					
Action/Comments						
Inspector Comments: Missing fall protection railing at the pump inlet.

View of fall protection cable at the pump inlet. Photo taken July, 2018.
